Photos of Shepherd Filters becoming loaded with grease over time at the same location. Please note that there is no set time frame for this progression, it depends on how much grease is being produced by the kitchen. Heavy constant frying will make this progression happen quicker than occasional frying mixed with the use of other cooking equipment.

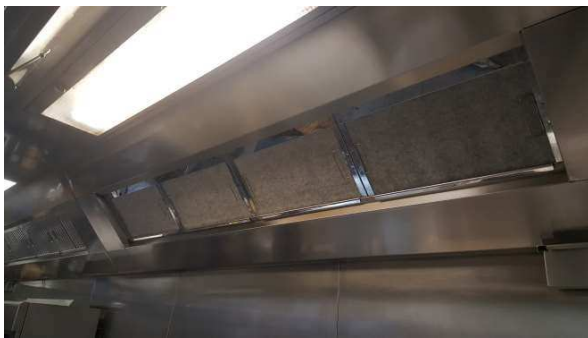
New Filters Installed.

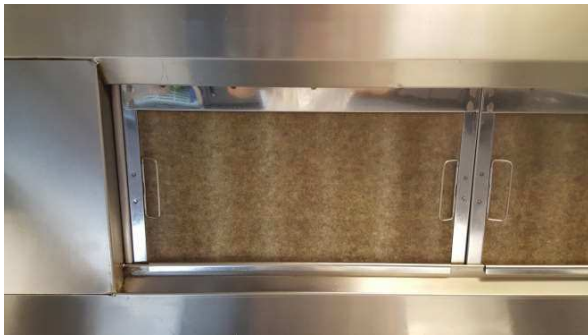
Filters starting to show grease accumulation. Notice the “ribs” of the baffle filter becoming visible.

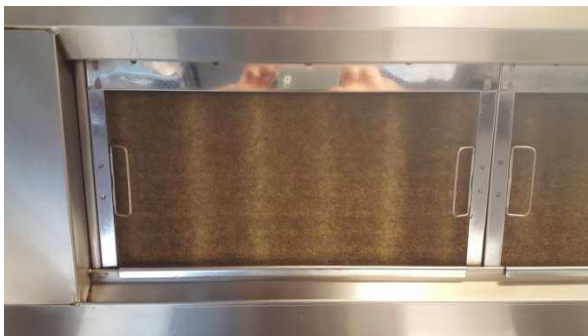
Further accumulation, ribs becoming clearly visible.

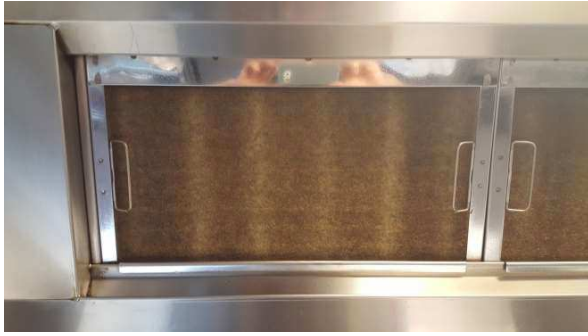
Further accumulation, ribs clearly visible.

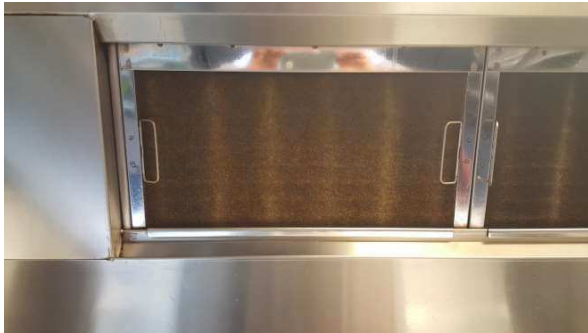
Filter becomes darker as it captures more grease. Behind the wool filter, the baffle and hood are still clean.

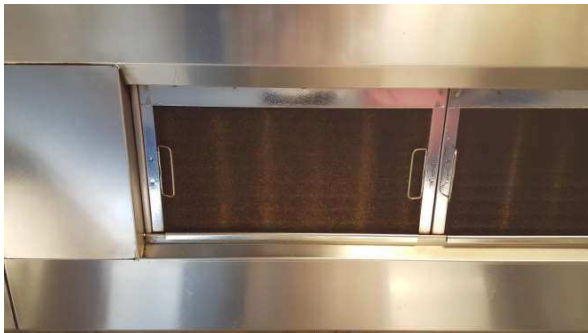
This filter is *nearing* the end of its service life. When the ribs of the baffle can no longer be seen, the wool needs to be replaced.

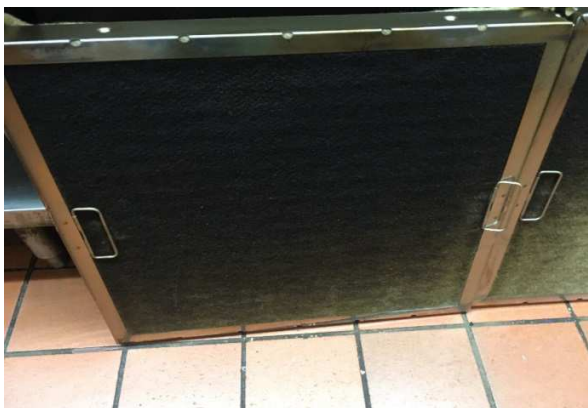
This filter was positioned above a gas radiant char-broiler and is now at the end of its life. This unit went through the same process as the filters above, but turned a darker color due to different by-products of the cooking process.
